# Cobble Berms and other Coarse but Adaptable Natural Shoreforms

Bob Battalio, PE  
April 2019 – Ocean Climate Summit  
San Francisco, CA

# Toward Natural Shoreline Infrastructure to Manage Coastal Change

## A Report for California's Fourth Climate Change Assessment

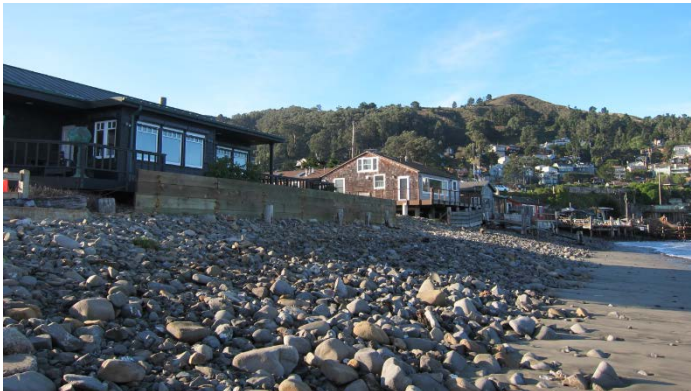
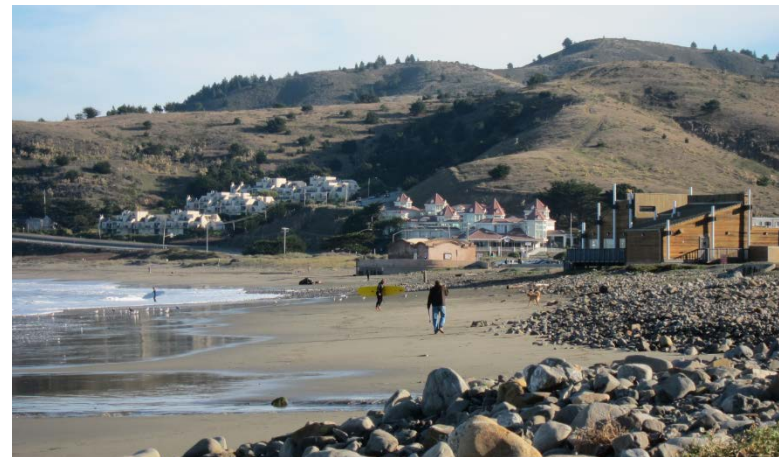
Pacifica State Beach Photos Peter Baye

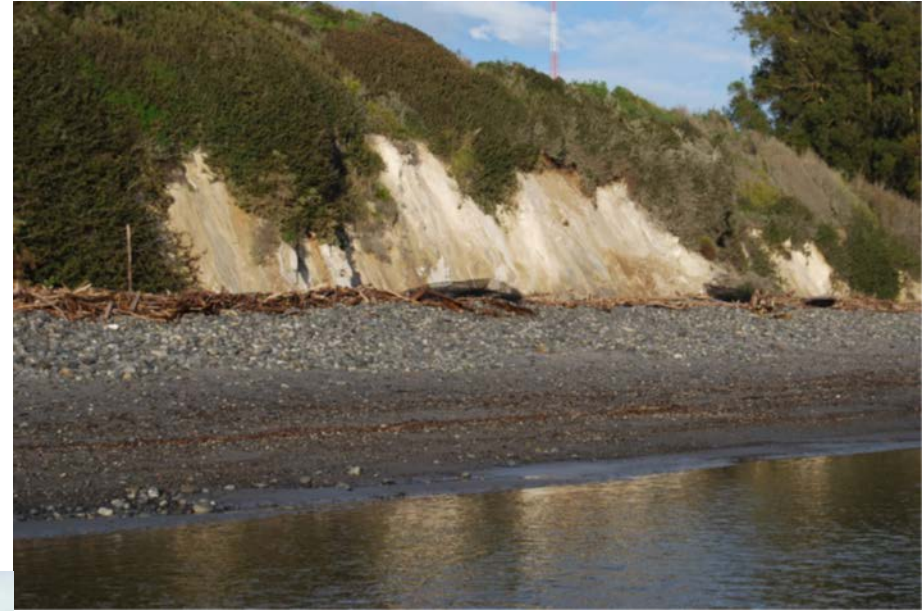
(right)

Cobble berm – lag deposit Goleta, Santa Barbara County, 2017. This cobble is typically covered with sand but has remained exposed after extreme winters 2015-16 and 2016-17. Source: Surfrider Foundation.

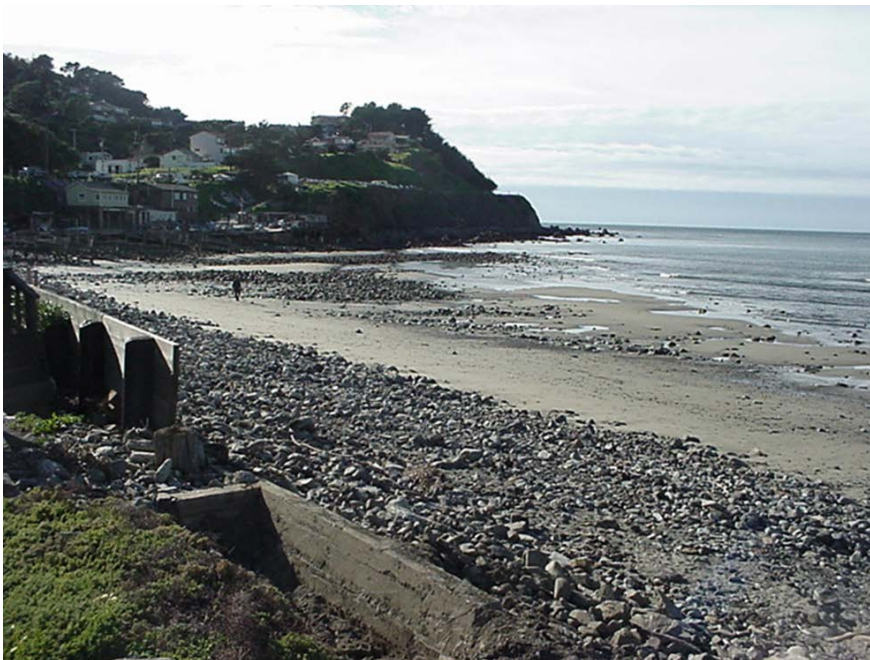
(left)

Pacifica CA in eroded condition at low tide with cobble lag-substrate exposed. Picture 2005 by Bob Battalio, ESA.

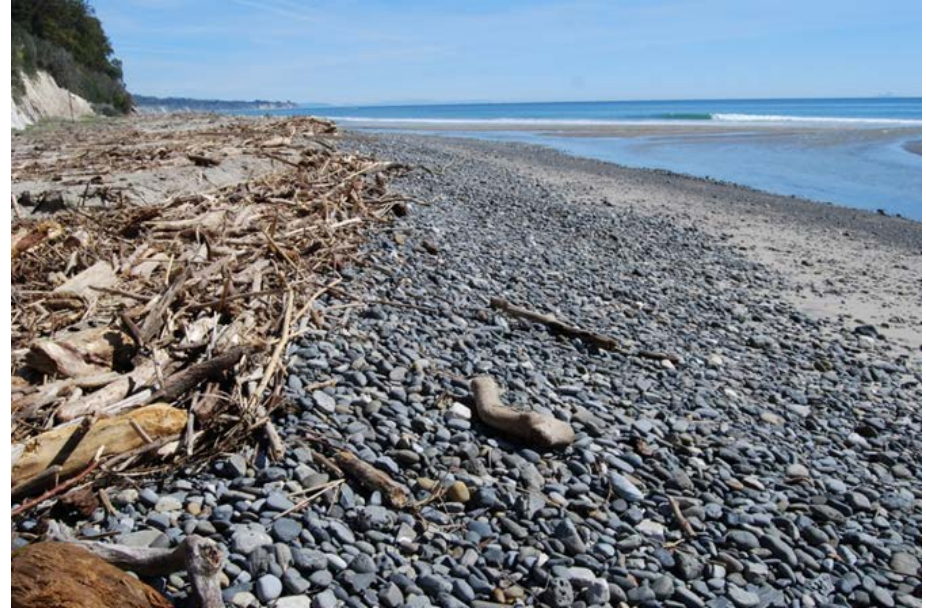
(right)  
Cobble Berm, Goleta, Santa Barbara County, CA. March 8, 2017. Note deposition of wrack on berm crest, indicating extent of wave runup and physical process supporting ecological function. Source: Surfrider Foundation.

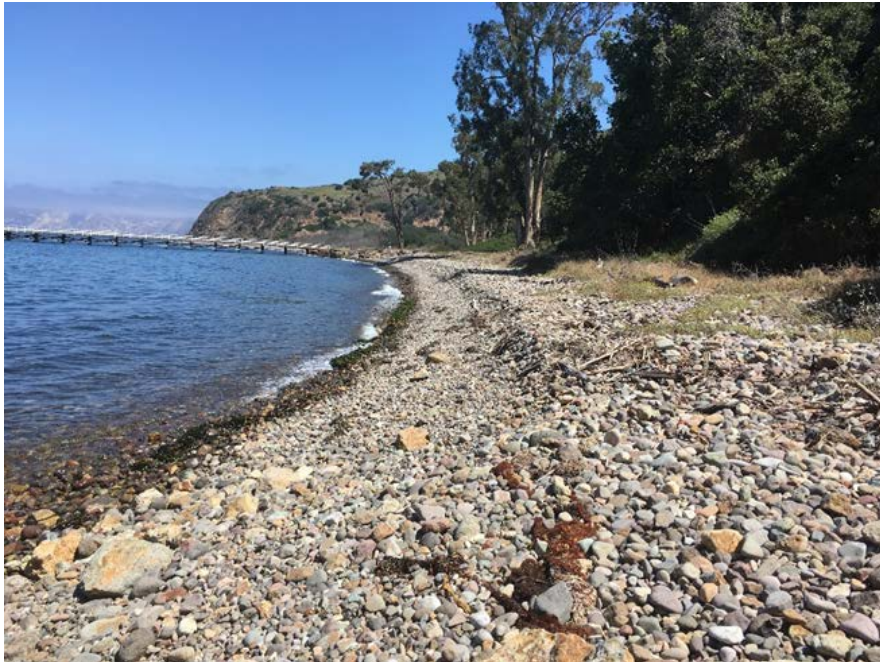
(left)  
Cobble berm at Prisoner's Harbor, Santa Cruz Island, CA. Photograph by Jenny Dugan.

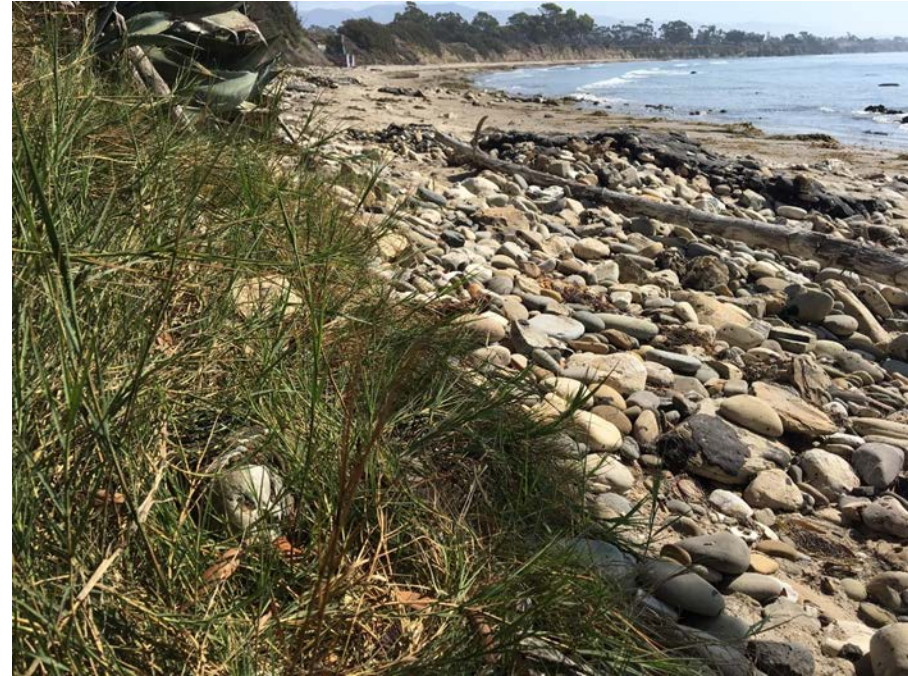
(right)

Salt grass established on cobble berm in Goleta, Santa Barbara County, CA. August 30, 2017. Photograph Dave Hubbard.

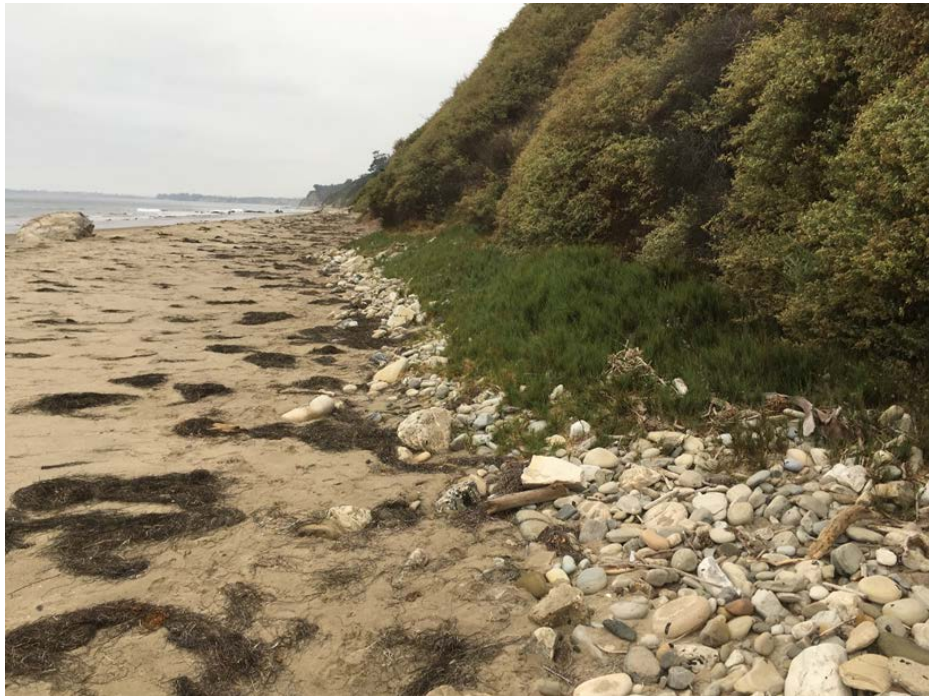
(left)

Salt grass established on cobble berm at Arroyo Burro Beach, Santa Barbara County, CA. Photograph by Jenny Dugan.

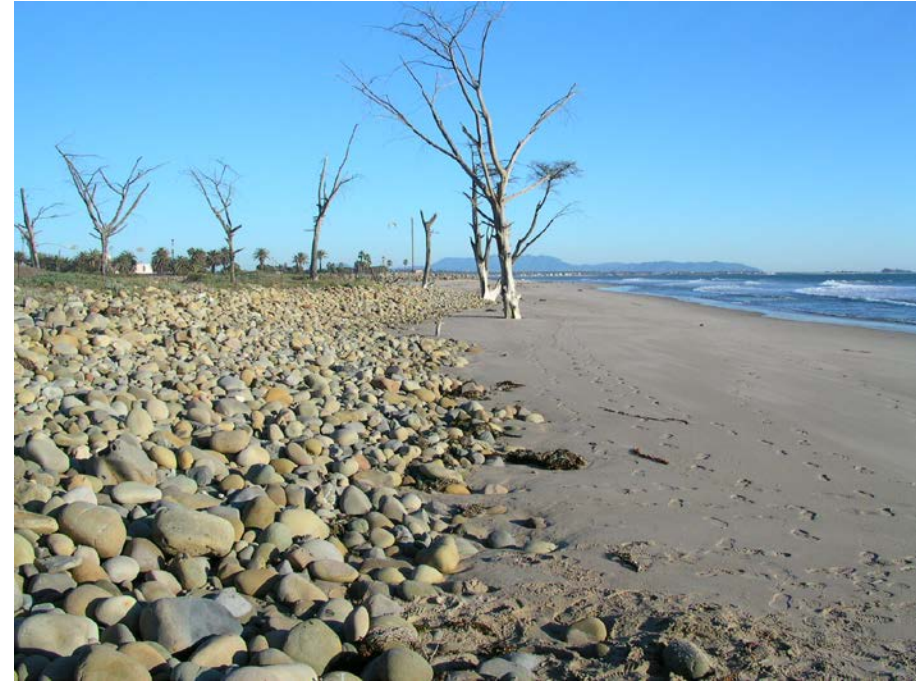
(right)  
Emma Wood State Park. Migrating cobble berm backed by vegetation and fronted by sand. Reference sight for Surfers Point. Early 2000s. Photograph: Bob Battalio.

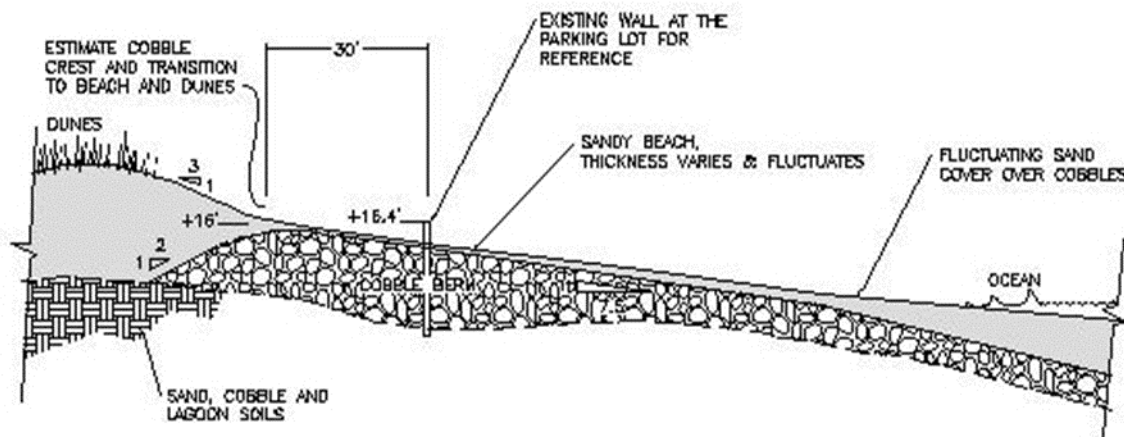
(left)  
Conceptual cross-section for Pacifica State Beach managed retreat and backshore restoration.  
Source: PWA, 2002

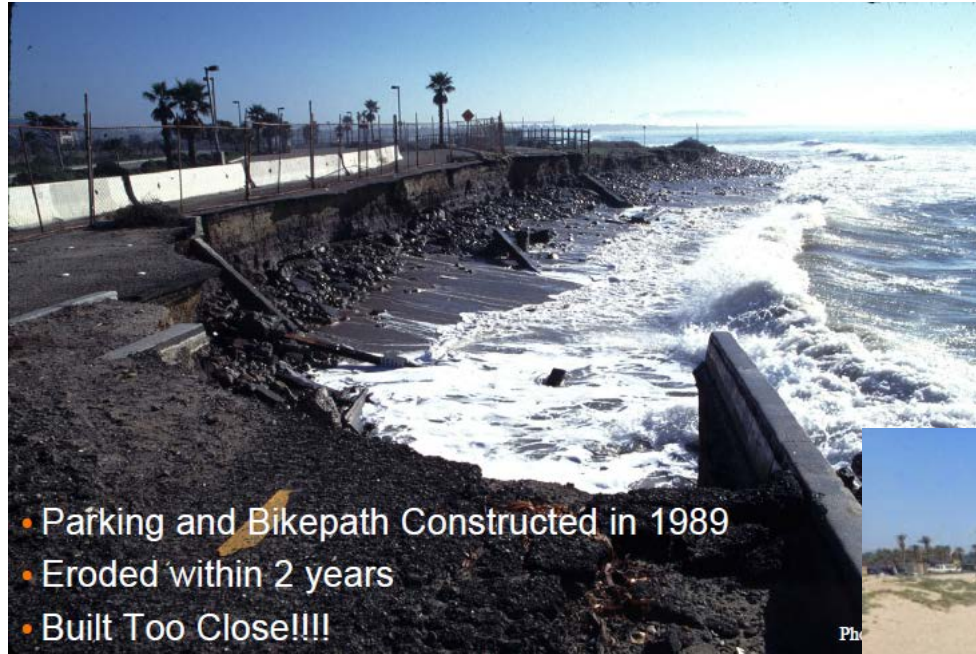
**Before**

Ventura, CA  
Open-coast environment  
Eroding rivermouth delta

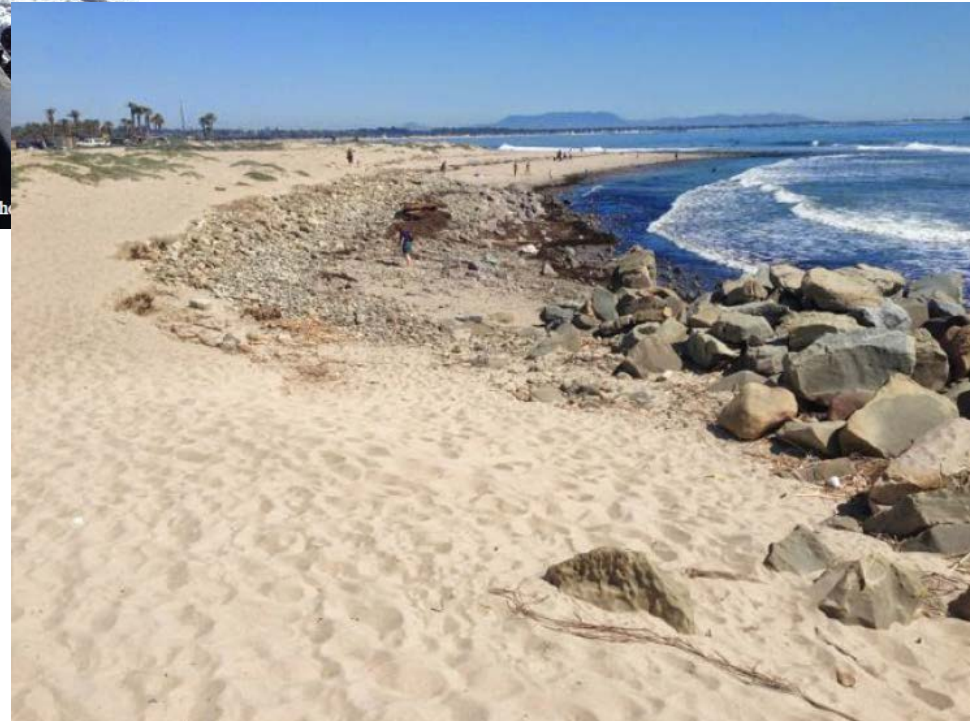
**After**

Extreme Swell Event, December 11, 2015

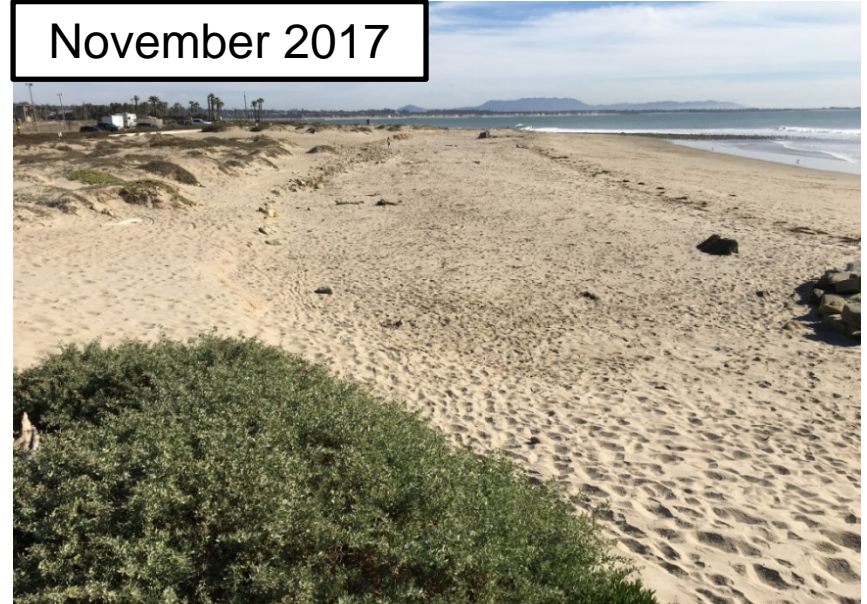
November 2017

Boulder Fingers  
retain cobble  
where oblique  
wave approach; to  
build-out delta  
shore

Concept developed  
by Surfrider  
Foundation  
(Ventura Chapter)  
and ESA 2017
